Blowing the whistle on Stevenson screens

A climate-change critique by Dr. Bill Johnston

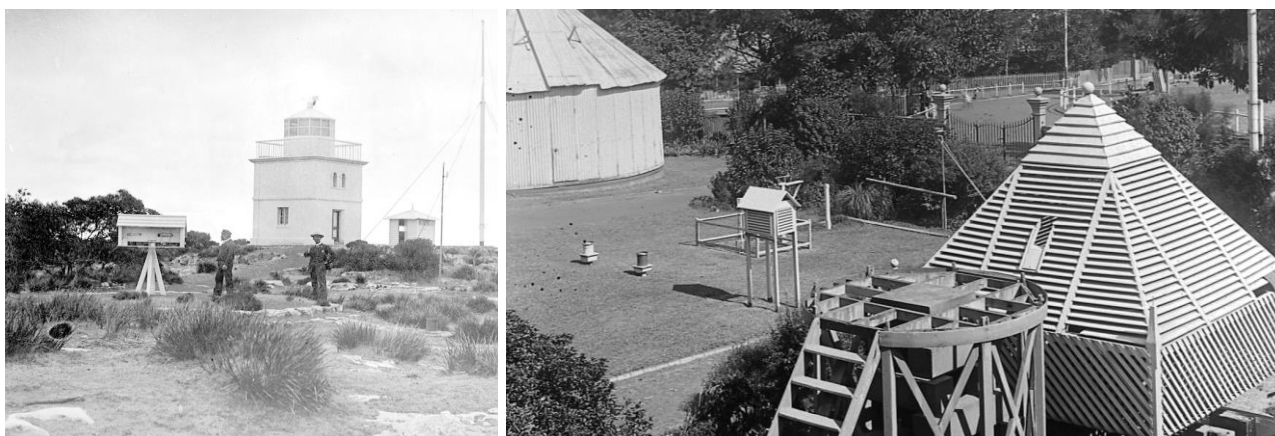
Figure 1. Temperatures measured in the open-fronted Glaisher stand at Cape Borda lightstation, Kangaroo Island SA in 1903 and the pyramid-like 'thermometer house' at Sydney Observatory before 1908 are not necessarily comparable with those measured in Stevenson screens, such as the one in the centre of the Observatory lawn. (Photographs courtesy of the State Library of South Australia (L) and the Museum of Applied Arts and sciences, Sydney (R).)

Large 230-litre Stevenson screens were the mainstay instrument shelter since exposure of Australian meteorological thermometers was standardised in 1925¹. Temperatures measured under different conditions are not necessarily comparable (Figure 1). Referred to as exposure bias, differences between shelter types are detected objectively using statistical tests (or photographically using a camera!)

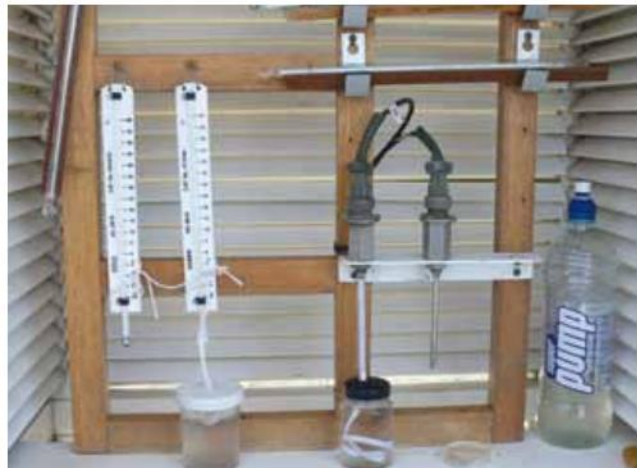
Figure 3. Placement of instruments in the 230-litre Stevenson screen at Hobart airport (L., photographed in October 2016) on the same plane relative to the north-facing rear wall (right) minimised spatial bias. The Tmax thermometer is out of sight.

Adding further confusion, Figure 5 in the *Australian Climate Observations Reference Network – Surface Air Temperature (ACORN-SAT) Observation practices* bulletin (p. 10) shows the internal layout of the 230-litre screen at Hobart airport, but describes it as that of a 60-litre screen (Figure 3). Holding instruments on the same plane parallel with the north-facing rear wall minimises spatial bias as the screen warms and cools through the day.

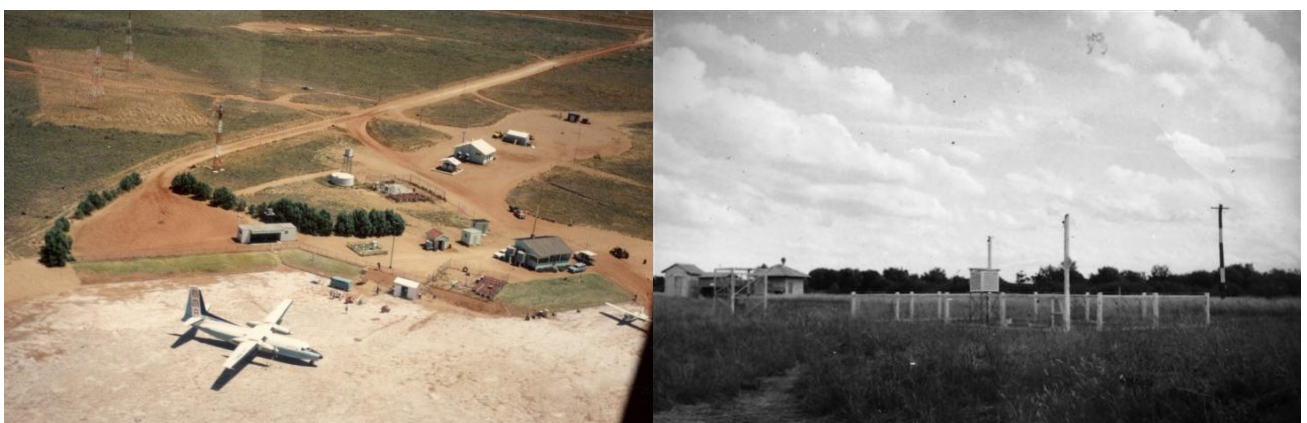
Figure 5. The original instrument enclosure (centre, in front of the trees) and surrounds in the vicinity of the Aeradio office at Onslow WA, photographed in 1964 (L) were watered, probably to control dust. Observations were suspended after cyclone Trixie demolished the place in 1975 until 1997 when an AWS was installed at an unwatered site beside the runway. That site moved further away in 2002. While the climate was unchanged since observations commenced in 1939, data were warmed artificially by site moves and instrument changes. At Charleville (Qld) (right), metadata ignored that the original Aeradio site was near the WWII operations centre on the northern side of the aerodrome near the town racecourse. The effect of moving to the new met-office in 1956 was adjusted out of the data using rainfall as a co-variable. (Photographs courtesy of Dawn McAullay (L) and CAHS.)

Forgetting where the original Stevenson screens were located and the conditions under which observations were made is also commonplace (Figure 5). For instance, photographs show Aeradio sites at Mildura, Onslow and Port Hedland airports and the yard at the Marble Bar and Bourke post offices were shaded or watered, and that original Aeradio sites at Canberra, Norfolk Island, Amberley, Sydney airport, Charleville, Meekatharra, Rockhampton, Launceston, Darwin, Townsville, Halls Creek, Cairns, Oodnadatta and elsewhere were not where metadata claim they were. Such looseness with important details is unacceptable.

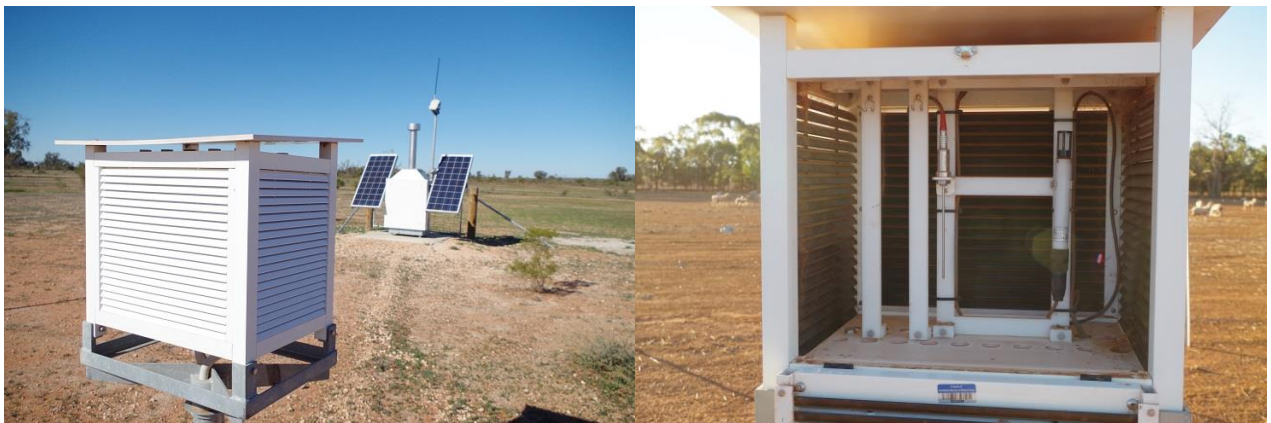
Figure 6. In the middle of no-where and surrounded by a stony gibber-plain, the 60-litre PVC screen at Wanaaring (Delta) is biased-high. Matt-black internal louvers radiate heat into the screen increasing the likelihood of temperature extremes especially on windless warm days. (Photos by the Author.)

PVC screens have not been evaluated as fit for purpose. Their closely-spaced louvers would warm up quickly and their matt-black interiors would radiate a high proportion of that heat onto the instruments than would be the case for white-painted wooden screens (Figure 6).
